**TIMBER COTTAGE  
CROCKERTON GREEN  
LONGBRIDGE DEVERILL  
WARMINSTER  
WILTSHIRE**

**TREE-RING ANALYSIS OF TIMBERS**

**April 2025**

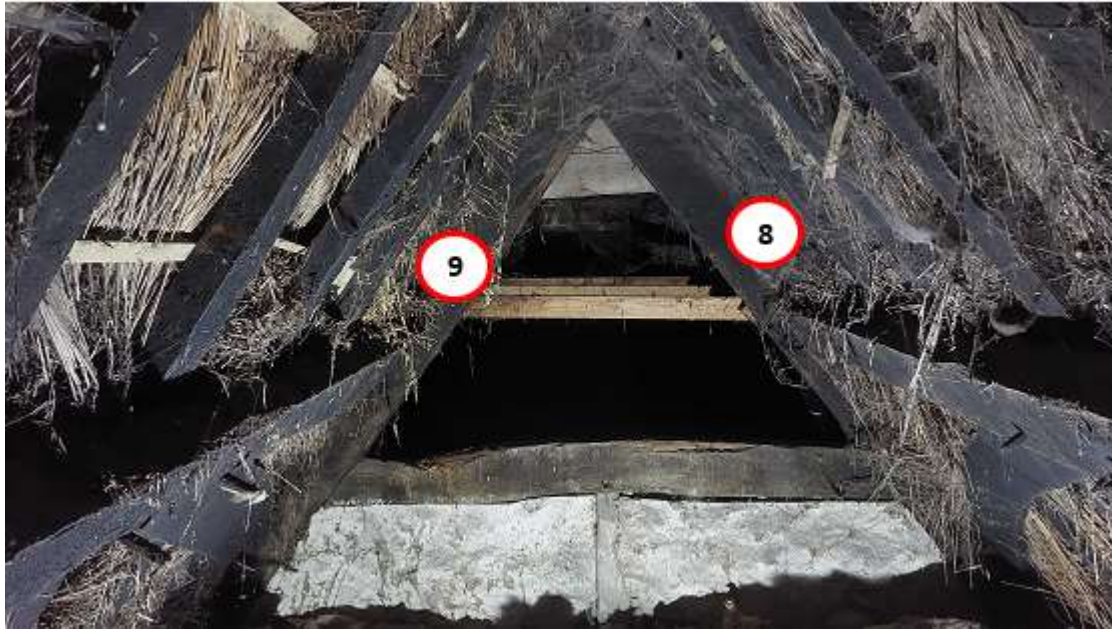
**Figure 3c:** Annotated photograph to show sampled timbers to truss 4 (viewed looking south) (see Table 1 and Figure 2)

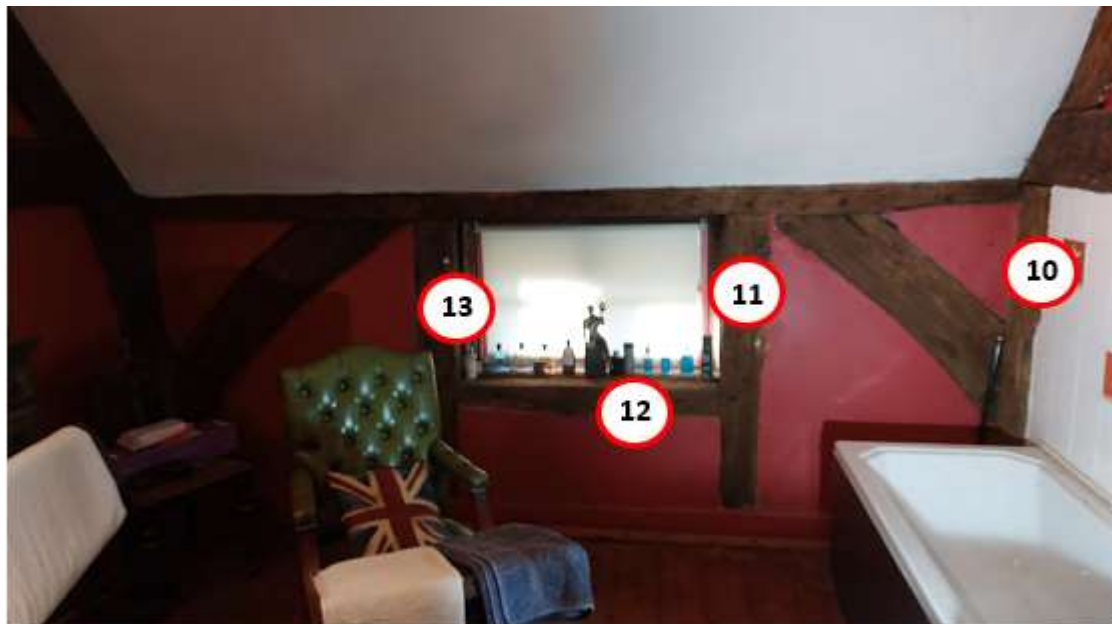
**Figure 3d:** Annotated photograph to show sampled timbers to bay 1 (from north) looking west (towards the road frontage) (see Table 1 and Figure 2)
