A VIEW FROM THE RAFTERS

July 2020

No. 1

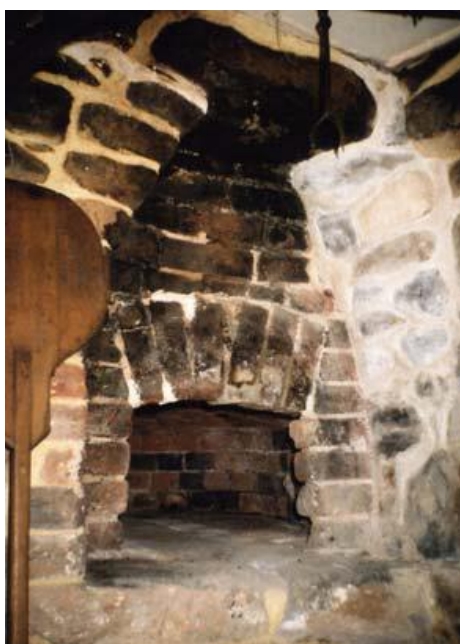
Bread oven at Castle Cottage, Lockeridge

Recently a dimensional survey was carried out at a cottage in Lockeridge in the upper Kennet Valley, for the current Dendrochronology Project. Included in a relevant gable wall was a bread oven.

They were built entirely of brick, including a somewhat flat dome. They are of an 'egg' plan shape with a semi-circle at the opposite end to the opening, which is 420mm wide x 300 mm high. One had a metal door and frame whereas the other had evidence for one. On the metal door was the trade name 'Carron' - still in existence (kitchen sinks).

On drawing up the survey, I looked through the record of bread ovens which I have surveyed over the years, only to find one of very similar dimensions, designs and materials. This one was at Marston near Potterne. So close was the detailing that I am now wondering if; a) they were built by the same builder who had a 'formula' for their design, or b) different builders used the same 'pattern' design. I have not known of any 'patterns' existing.

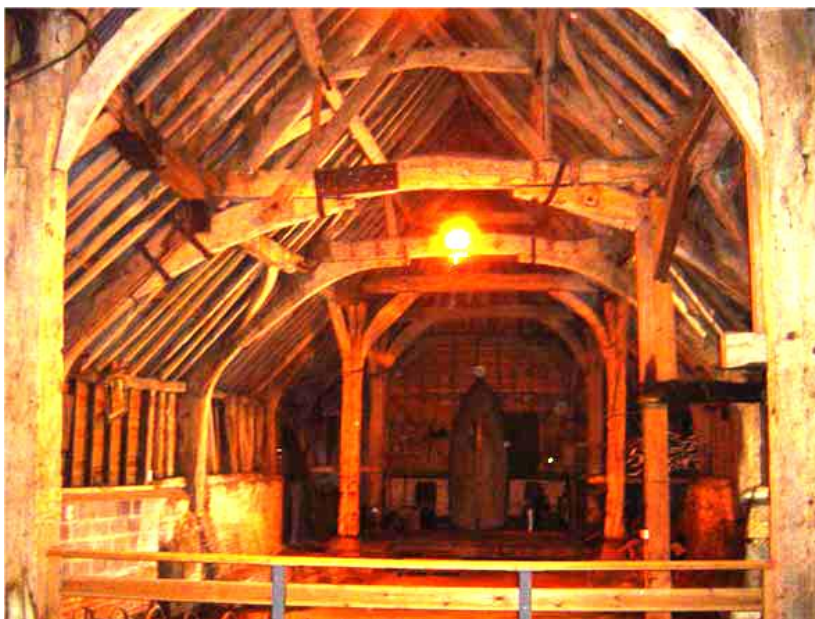
***Interior of the barn
showing the two
different truss types:***

*base crucks in the
centre
and
post and aisle
trusses at the north
and south ends.*

This late medieval timber-framed barn appears to have been constructed in a single phase but uses two entirely separate truss types: base crucks and post and aisle, in a similar manner to the former barn at Cherhill, now demolished. The two techniques do, however, suit different agricultural operations within the same building and this is something we will report on further later on in the project. **Avis Lloyd, Project Officer**

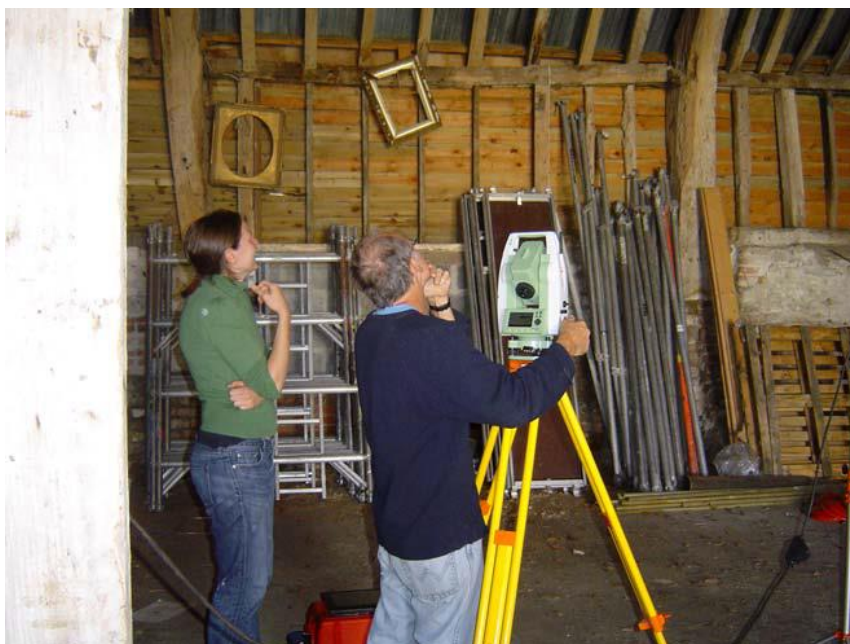
Nigel Fradgley & Rebecca Lane of English Heritage, producing truss sections by EDM

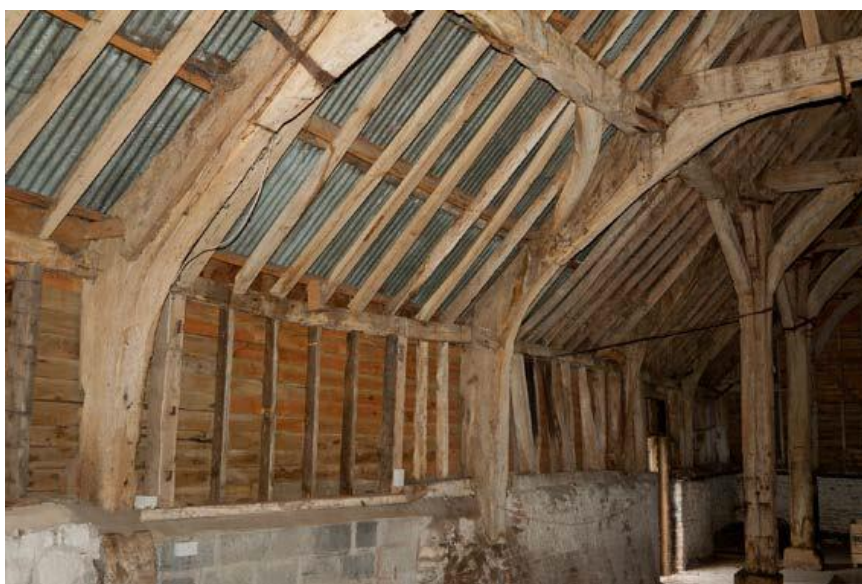
Barn at Kingston Deverill. Photo: Alex Craven

Wiltshire Buildings Record's dendrochronology project dated this very early barn of mixed-truss construction to 1407-10.

Imagine the satisfaction when Alex Craven, assistant editor of the Wiltshire Victoria County History, discovered a document giving a great deal of detail about materials and where they were sourced from. It gives a fascinating insight into the process of barn-building and what a wide geographical area that men and materials were brought in from.

40 oak trees cut down in Bittele; and 15 more
4 oak trees cut down at Knoel (?Knoll) for the two main braces (crucks)
Stone for the wall under the sill around the grange, freestone from the quarry at Fontell (?Fonthill) for coping the same
4 'gross' of freestone for supporting the four principal braces (crucks) and freestone for the 8 posts within the grange and for the 'Boterasses (buttresses)'. Carriage of this stone from quarries at Penne (present day Penselwood in Somerset) and Fontell
1 mason dressing the 8 stones 8 holes (puteis) for 8 posts within the grange
9 Flint dug from various fields and places for the wall below the sill
2 men digging chalk for burning to make lime
Coal from Menydepe (Mendip) for burning the chalk
21 quarters of chalk stone
Wet sand (zabulo aquat')
Dry sand dug at Maiden Bradley
16,000 (ml) laths
2,000 'brodstone' (probably thin flat stone) extra to the old stone for roofing the grange

Carriage of this stone from Upton
2 sawyers for cutting timber of the lord for 'ovesbordes' (barge boards?)
Moss collected from various places for placing between the stones instead of mortar at harvest time
1 roofer re-using materials from the old grange
Spikynges ...
New tiles bought over and above the old one re-used
Walter Badecok, reeve, for travelling to find carpenters, masons and roofers in Wells, Bruton, Phillips Norton and elsewhere.

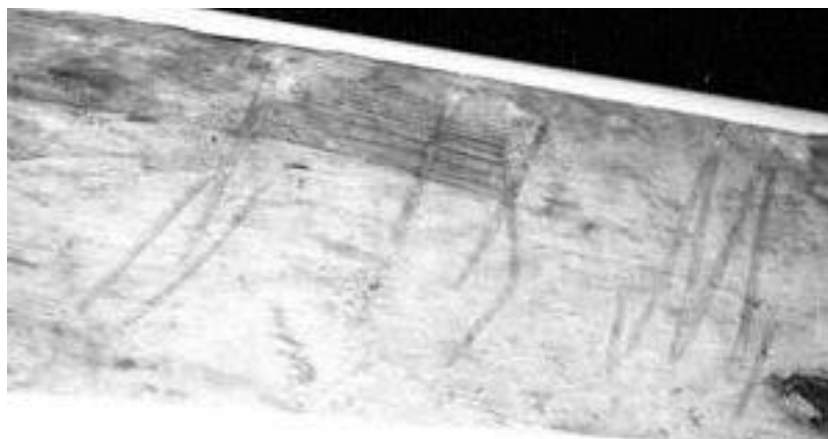
Cargo marks at Parklands Hotel, Ogbourne St George

I have often come across them in 19th century buildings on sawn softwood timbers, mainly in the roof. They are sometimes confused with carpenters marks, but cargo marks are not related to joints, or assembly of a frame. They are put on imported timbers from the Baltic States for identification.

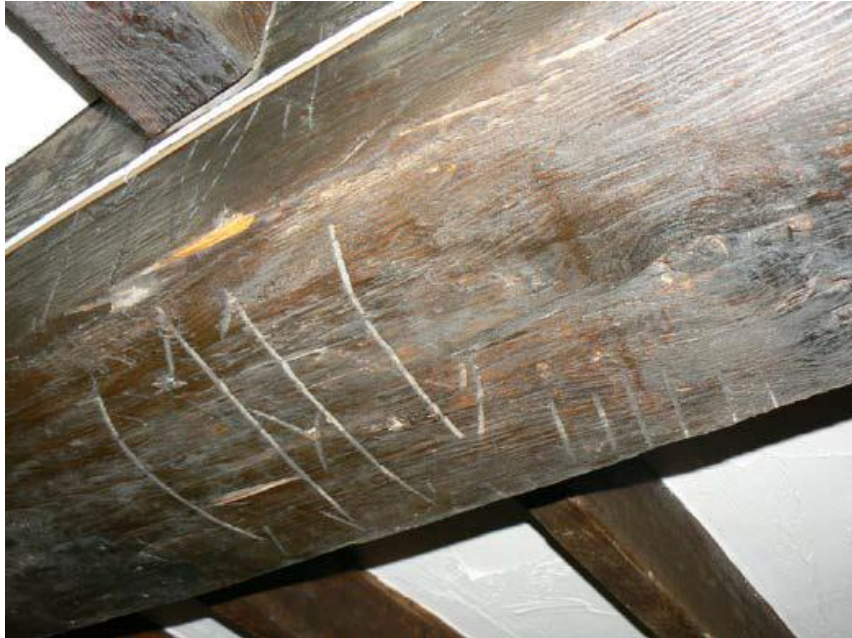
Cargo marks at 3 Bridge Street, Bideford. Photo by David Carter

They are all of the classic form which I see often, including handler numbers and batching marks. The earliest I've seen this type is the former ship magazine in Amsterdam which has been dendro-dated to 1786 and in the Ropery of Chatham docks of 1786-91.

In my experience, the vast majority occur between about 1810 and c.1850 - the latest I have ever seen them is in a dated barn of 1864, after which North American timber displaces the Baltic sources. Definitely no earlier than the later 18th century - earlier markings are much simpler - also many of the numbers have serifs - another 18th/19th century characteristic.

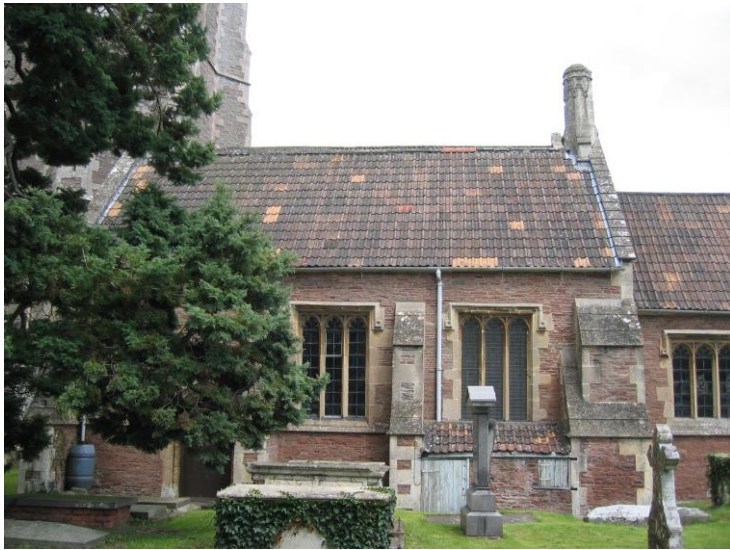
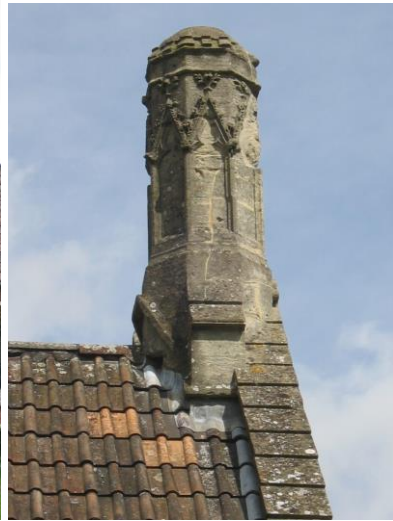
Amongst its interesting features the church had many pew ends with linenfold carving and there was a tall, narrow cell in the base of the tower said to have been the village lock-up. In the churchyard was a very fine 15th century market or preaching cross. I was intrigued by a medieval chimney at the end of the south aisle next to what had been a chantry chapel and can only think the building once incorporated accommodation for the chantry priest.

Iron Acton Church with medieval chimney. Photos: Alyson Curtis

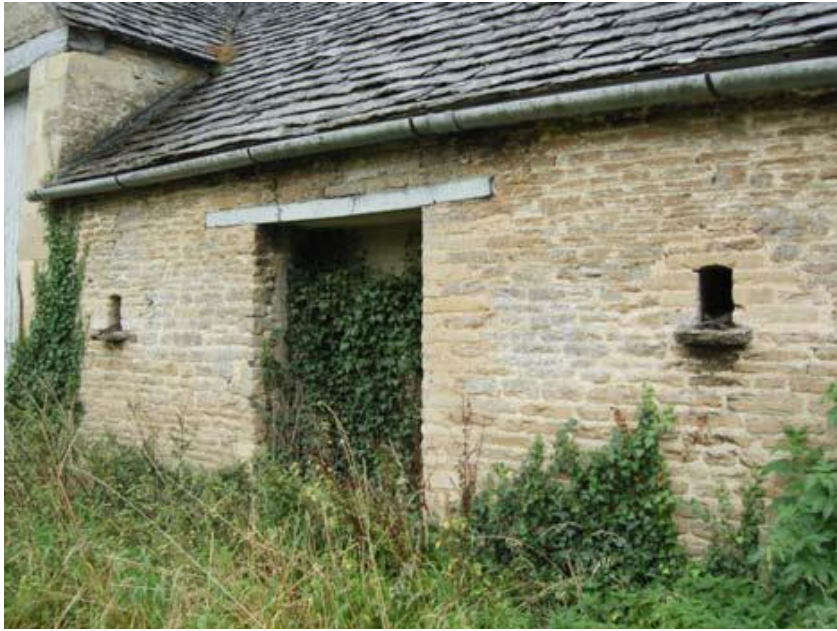
There is another example at May's Farm in a lean-to building next to the barn porch. The fittings inside may have been of timber as they are gone, but the characteristic external popholes remain. The hens would have climbed a sloping ladder to reach them.

Poultry House (the central door is an alteration)

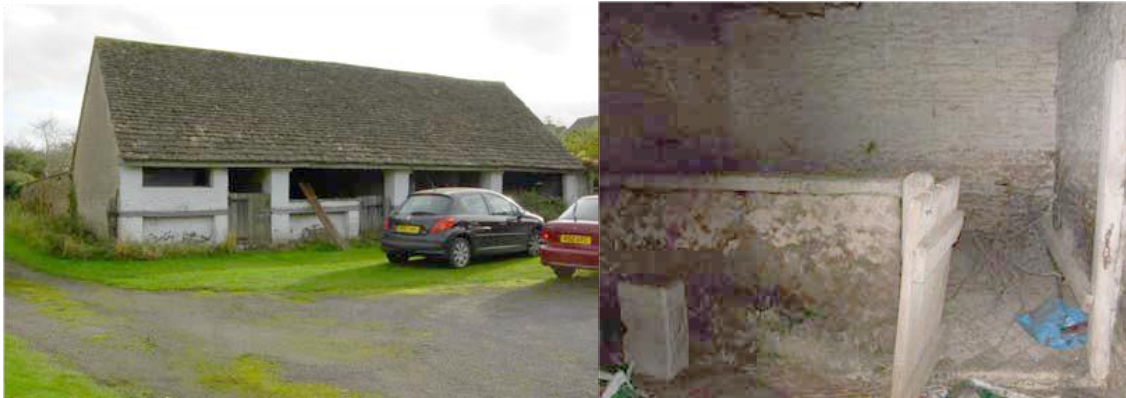
Pigsty range and interior

Also at May's Farm there is an unusual 18th century pigsty range where the outer run for the pigs is covered over as part of the building. This arrangement is sometimes found when a building with another function is converted to pigsties, but it is the first time I have seen it as an original feature. This building also uses large slabs of stone (the kind used for paving stones) in its partitions between the sties and the runs.

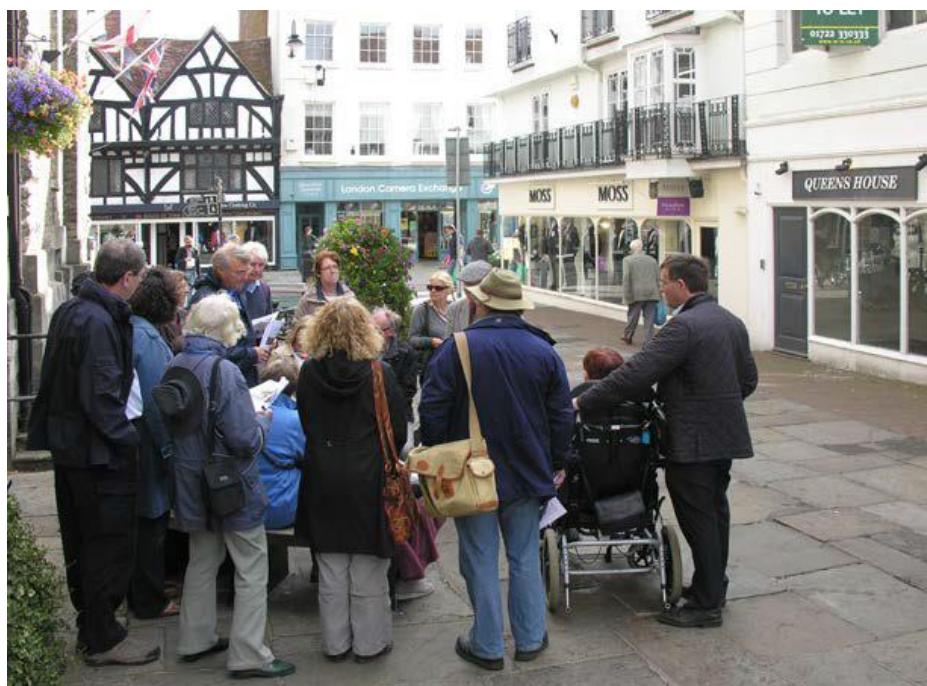
Looking at 3 Fish Row. Photo: Eric Peddle

3 Fish Row was built in the late C15, probably as a fishmonger's, and like the other buildings, is jettied. Salisbury was an important market for fish. During the restoration of this building in 1999 a large number of oyster shells were found under the ground floor. 9 Queen Street has a Georgian front which belies its timber-framed origins. This house is exceptionally early and has been traced to William Russel, a wool merchant in 1306. The house was raised in 1314, and this was visible on the first floor of the shop, where several different styles of window were seen. The roof above this is quite unusual – a raised tie-beam truss braced by a moulded, arched framework infilled by cut chalk blocks.
